HICKORY HILLS GOLF CLUB LAKE DAM (NO NAME NO. 235)  
JEFFERSON COUNTY, MISSOURI

MISSOURI INVENTORY NO. 30403

PHASE I INSPECTION REPORT  
NATIONAL DAM SAFETY PROGRAM

SEPTEMBER 1978

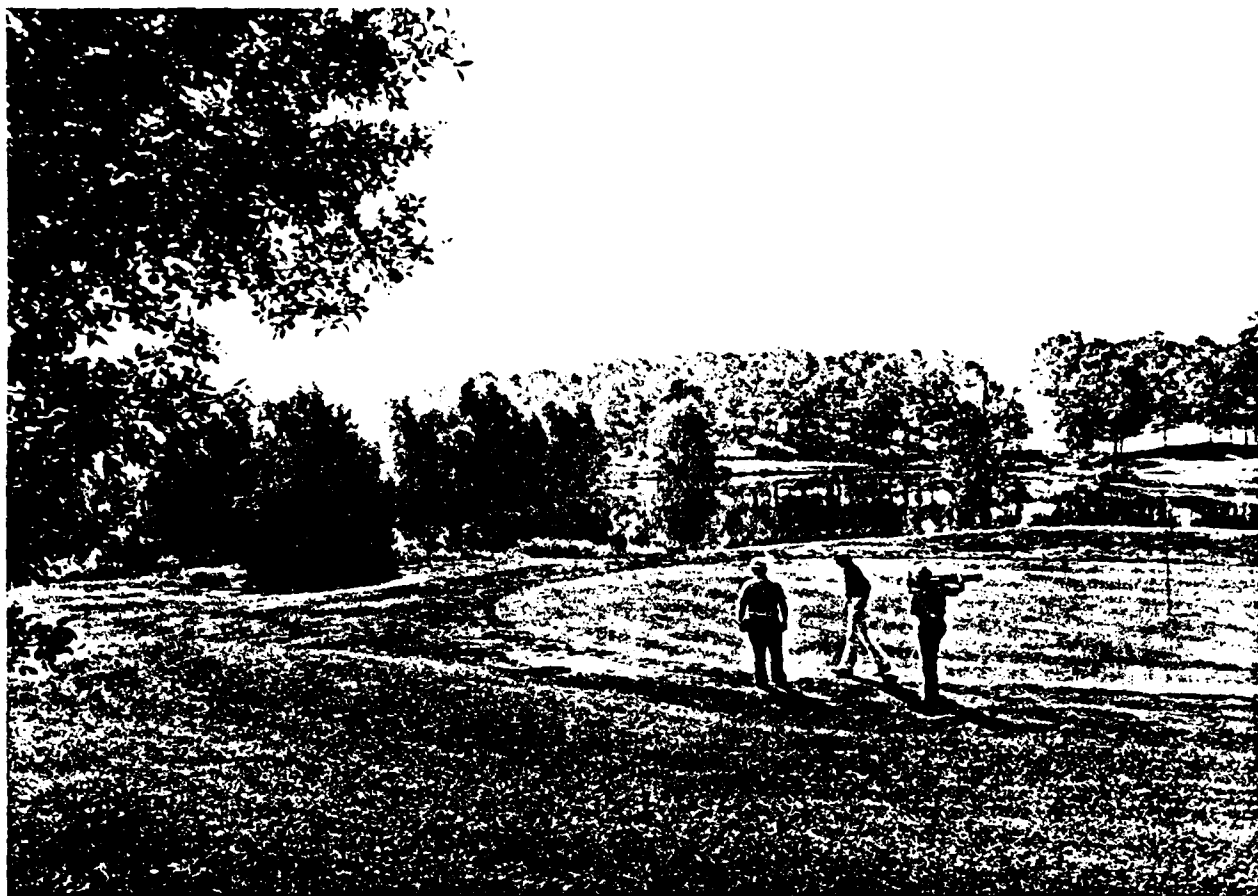
HICKORY HILLS COUNTRY CLUB DAM -  
LAKE OVERVIEW
